June 18, 2025

Aviation Investigation Report AIR-25-03

Mitigations Concerning Load Reduction Device Activation in CFM International LEAP-1B Engines

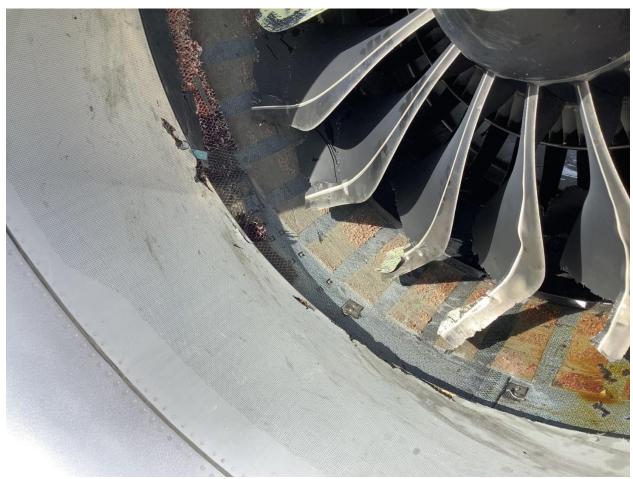
On December 20, 2023, about 1414 central standard time, Southwest Airlines flight 554, a Boeing 737-8, was departing from Louis Armstrong New Orleans International Airport (MSY), Kenner, Louisiana, when a bird was ingested into the left (No. 1) engine, a CFM International LEAP-1B, during the initial climb (figure 1 shows damage to the engine).² The flight crew reported that, after an uneventful takeoff and while climbing through about 1,000 ft, the first officer (FO), who was the pilot monitoring, heard the captain say "bird." This statement was followed immediately by

a "thump" on the left side of the airplane. The flight crew reported that the airplane began to "shake violently with a distinct loss of thrust" in the No. 1 engine.

Figure 1. Close-up photo of damage to the left engine. (Source: Southwest Airlines)

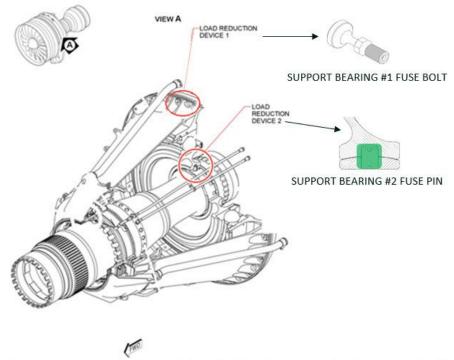
design feature on CFM International LEAP-1B engines. The LRD minimizes aircraft and engine damage during a fan blade failure or significant fan blade imbalance by reducing the severity of the vibration transmitted from the damaged engine to the airframe (see figure 2). The LRD does this by enabling the fan to be partially mechanically disconnected from the turbomachinery. As a mechanical design feature, the LRD does not require pilot intervention to activate.

Figure 2. The location of the LRD on the LEAP-1B engine. (Source: CFM)

Activation of the LRD in the MSY event caused tubes supplying oil to the engine sump to become dislodged and the flange from the sump area to open, which allowed oil to enter the core compressor upstream of the pneumatic bleed ports that supply bleed air to the cabin and cockpit.⁶ The oil was exposed to high temperatures and resulted in smoke and fumes that were then fed into the cockpit.⁷ When the FO pulled the engine fire switch, the smoke quickly dissipated because its

The NTSB is aware that CFM International, in collaboration with Boeing, has begun work on an engine software design update that they anticipate completing in the first quarter of 2026. The update will mitigate the presence of smoke or fumes in the cockpit or airplane cabin by closing the PRSOV when the LRD activates. This update will be entirely software-based and made available through a service bulletin upon FAA certification.

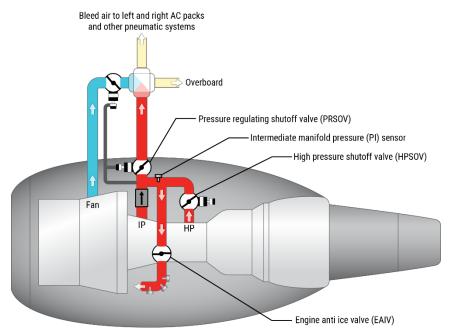
point of access, the pressure regulating shutoff valve (PRSOV), automatically closed.⁸ Each engine has a PRSOV that, when closed, prevents bleed air from entering the airplane (see figure 3).

Figure 3. Simplified engine bleed air diagram with PRSOV depicted. (Image Copyright © Boeing. Reprinted with permission.)
